Docket No. 424 – Development and Management Plan Inspection

The Connecticut Light and Power Company Certificate of Environmental Compatibility and Public Need for the Connecticut portion of the Interstate Reliability Project.

IRP Overhead ROW

Interim Week Inspection:

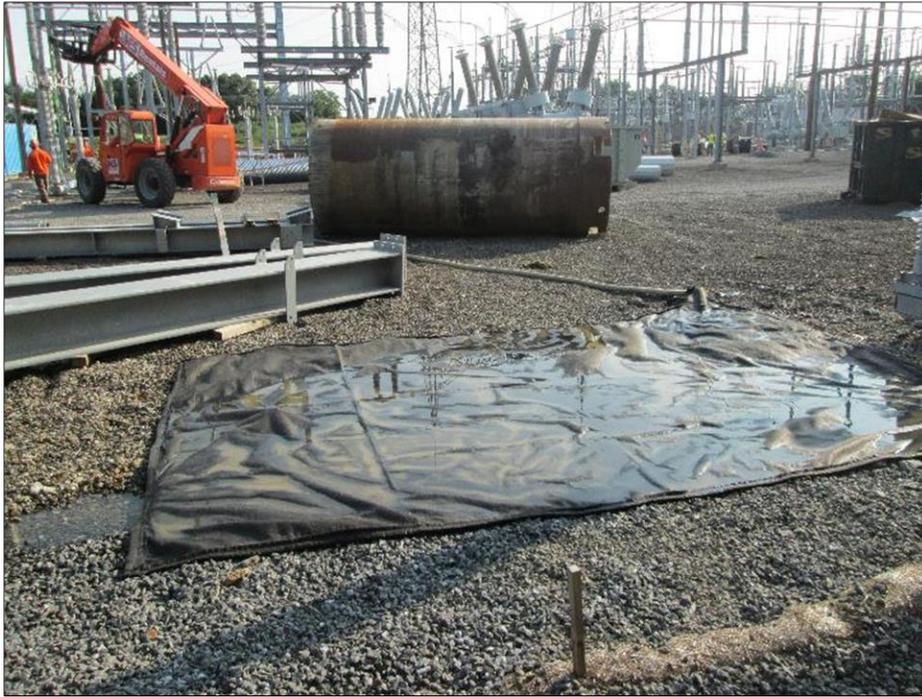
Photo #1: Dewatering into filtration sock "dirt bag" inside CSSS.

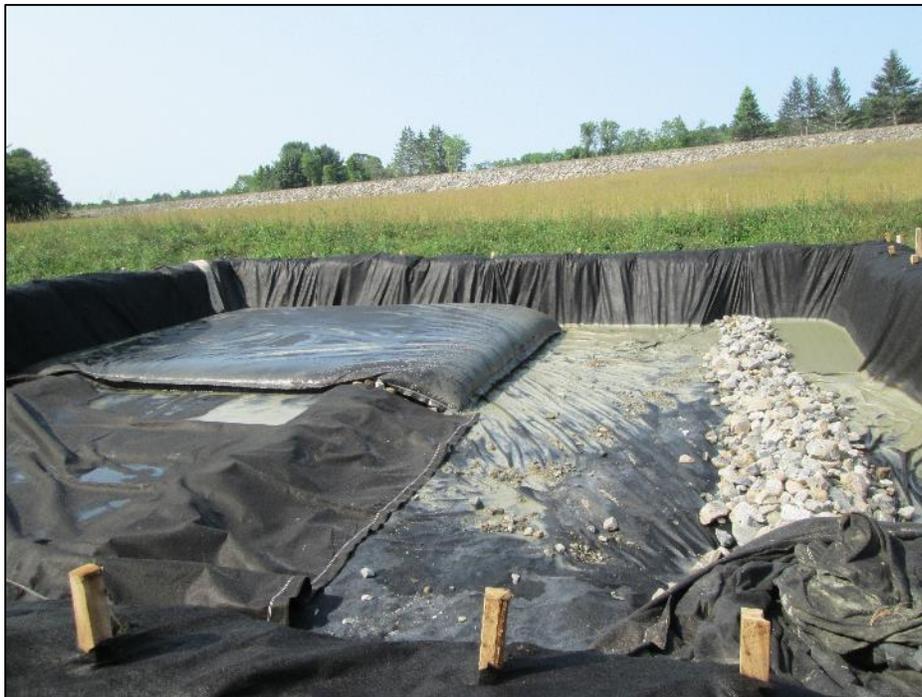
Photo #2: Check dams and "dirt bag" installed in dewatering basin down-line of Str 83.

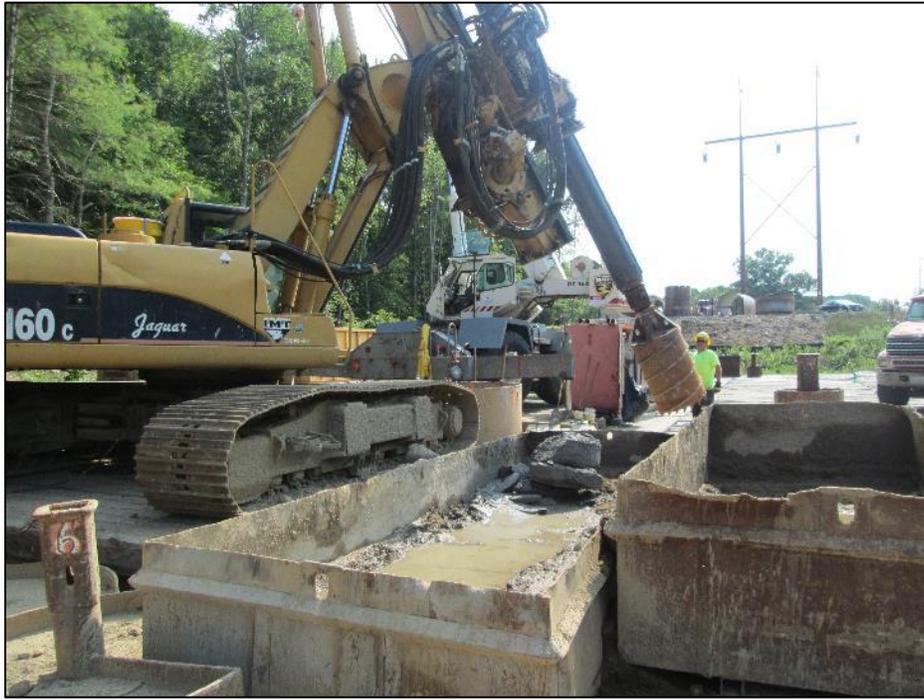
Photo #3: Spoils being contained in spin-off containers at Str 100. (7/25)

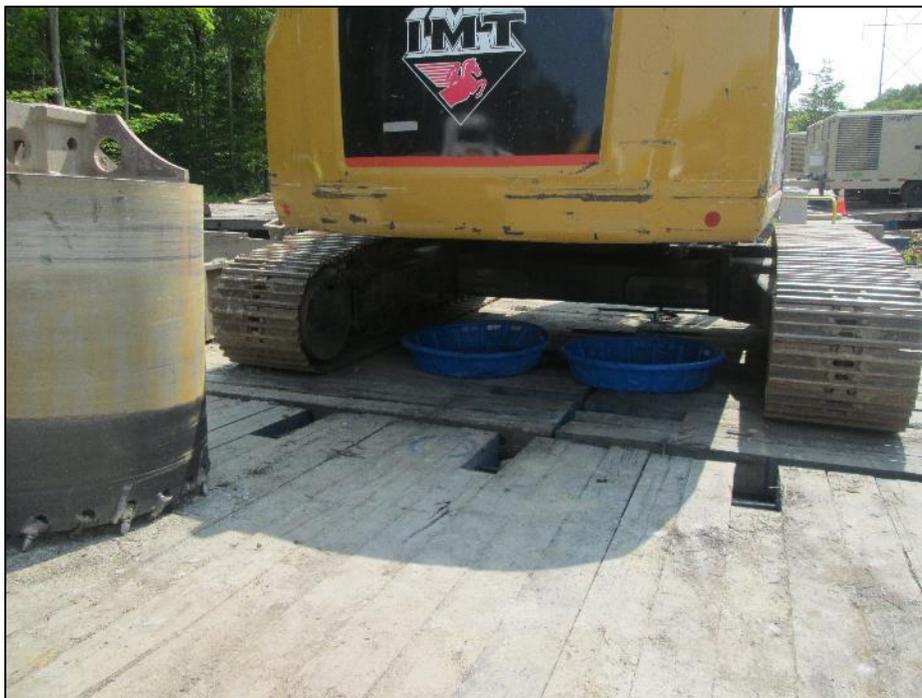
Spills and Material Storage.	Interim Week (7/25)	Spill kits noted on all visited sites. Str 104: Noted child pools under drilling machinery for precautionary measures. (Photo 4)	Continue to follow this procedure. Continue to follow this procedure.	NA NA
	Bi-Week (7/30)	Spill kits noted on all visited sites. Str 104: Filter fabric surrounding drilling operations in wetland area. (Photo 5)	Continue to follow this procedure. Continue to follow this procedure.	NA NA
Cultural Resources	Interim Week (7/25)	Pads in cultural areas are being installed with a geotextile separation fabric and sand buffer layer prior to the installation of the pad material.	NA	NA
	Bi-Week (7/30)	Pads in cultural areas are being installed with a geotextile separation fabric and sand buffer layer prior to the installation of the pad material.	NA	NA
Rare, Threatened, and Endangered Species	Interim Week (7/25)	NA	NA	NA
	Bi-Week (7/30)	NA	NA	NA

Photo #4: Child pool under machinery for precautionary measures at Str 104.

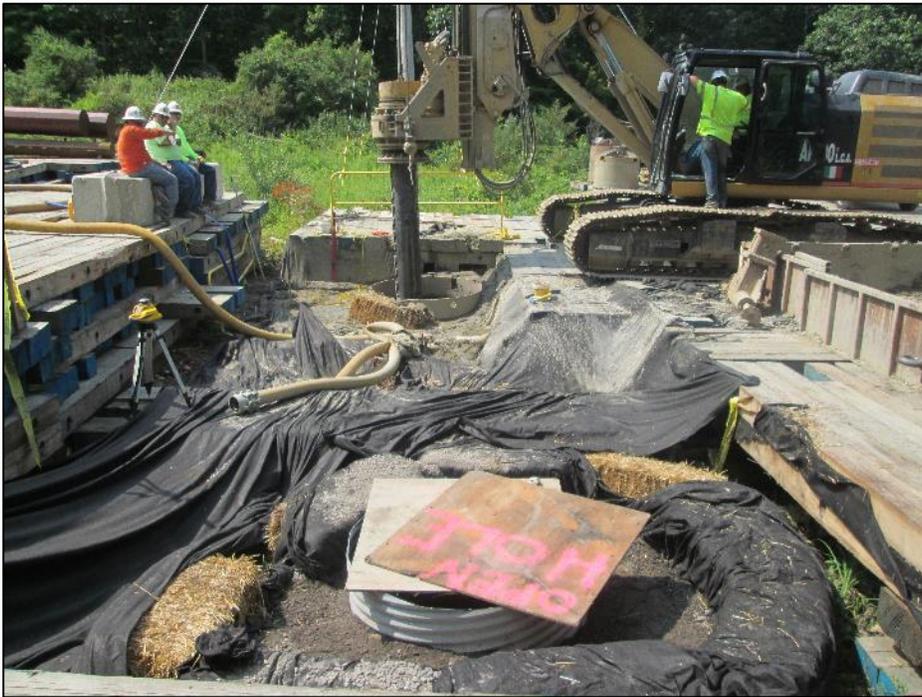
Photo #5: Filtration fabric covering surface for precautionary measures in wetland at Str 104.

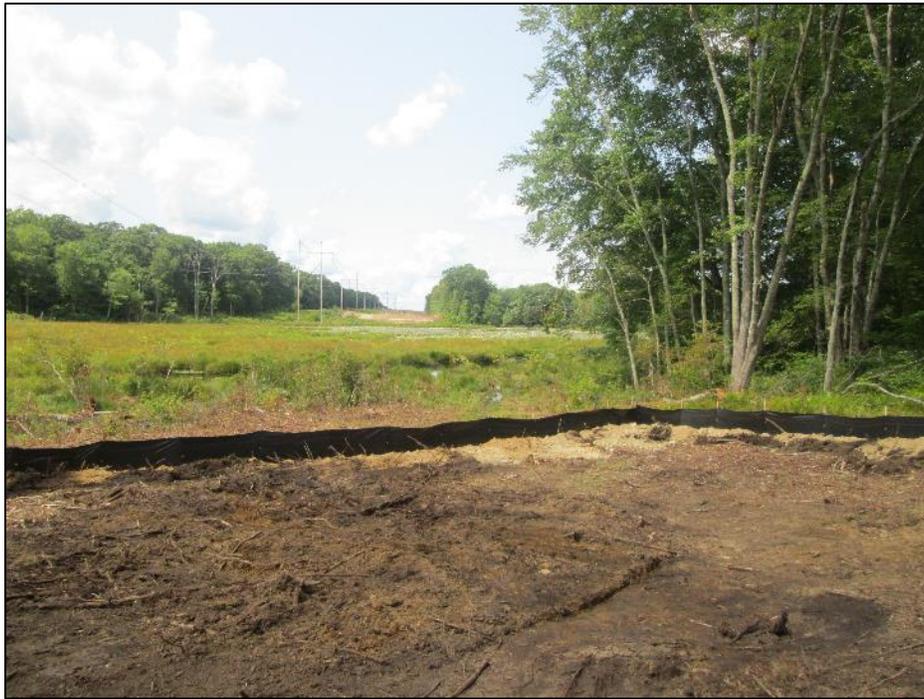
Photo #7: Erosion control measures at edge of wetland at Str 121.

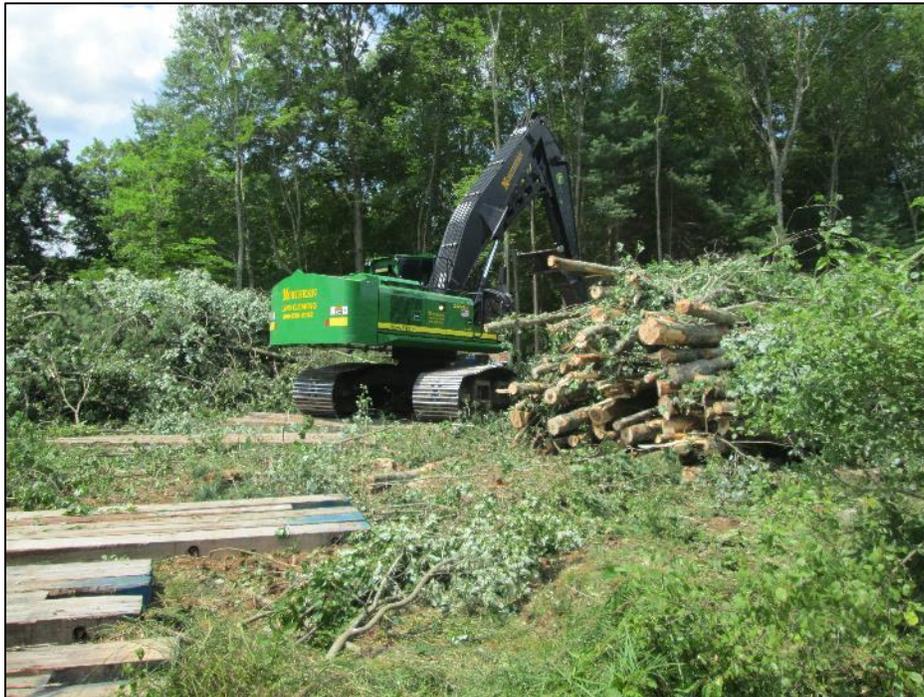
Photo #8: Clearing crews utilizing wetland mats to avoid rutting down-line of Str 153.

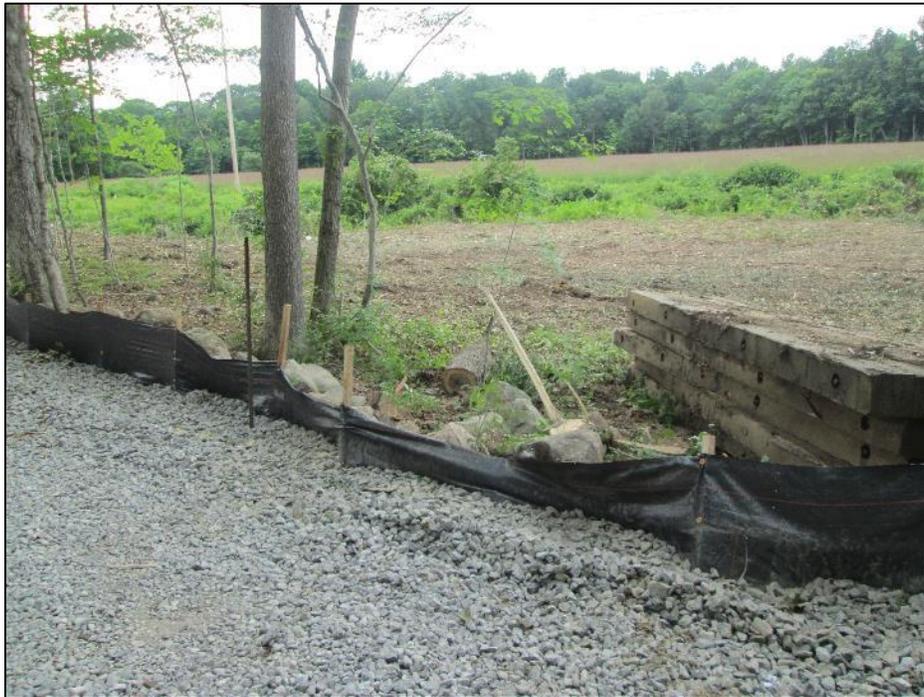
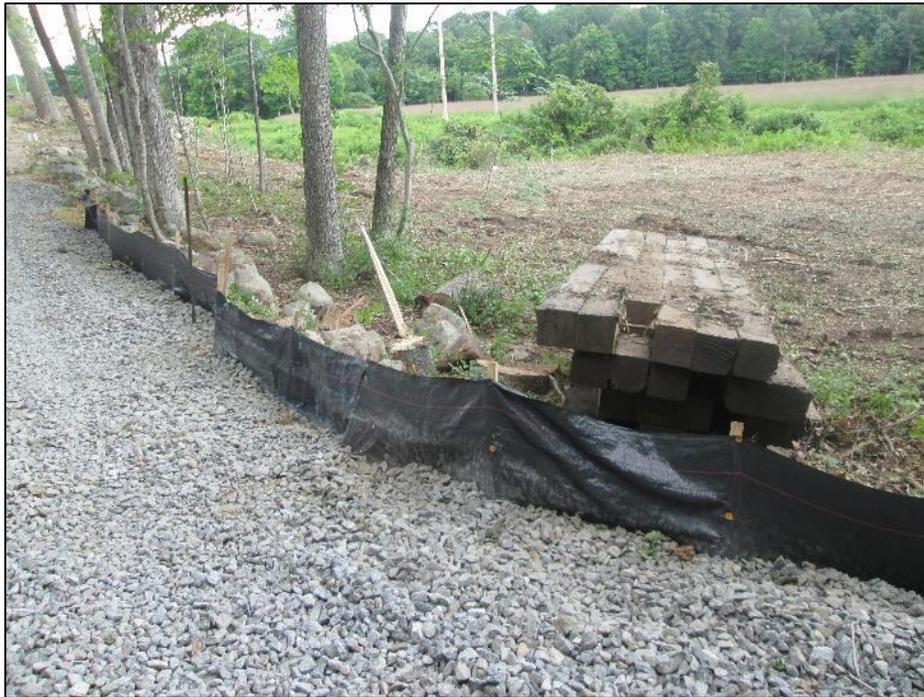
Str 144: Portion of silt fence damaged on side of entrance pad. (Photos 9 & 10)	NA	Northern crew immediately replaced portion of damaged silt fence.
Inland Wetland and Watercourse encroachment and mitigation	Interim Week (7/25)	Mat installations in wetland areas are in accordance with the BMP Manual.	Continue to follow this procedure.	NA
		Str 100: Wetland mats in 100-year Floodplain and Floodway are tied to each other to prevent migration during a flood condition.	Continue to follow this procedure.	NA
	Bi-Week (7/30)	Mat installations in wetland areas are in accordance with the BMP Manual.	Continue to follow this procedure.	NA

Photo #9: Portion of silt fence damaged at Str 144.

Photo #10: Portion of silt fence repaired immediately by northern crew at Str 144.
